Developments in Flight Recorder Equipment and Analysis

Neil A. H. Campbell MO3806

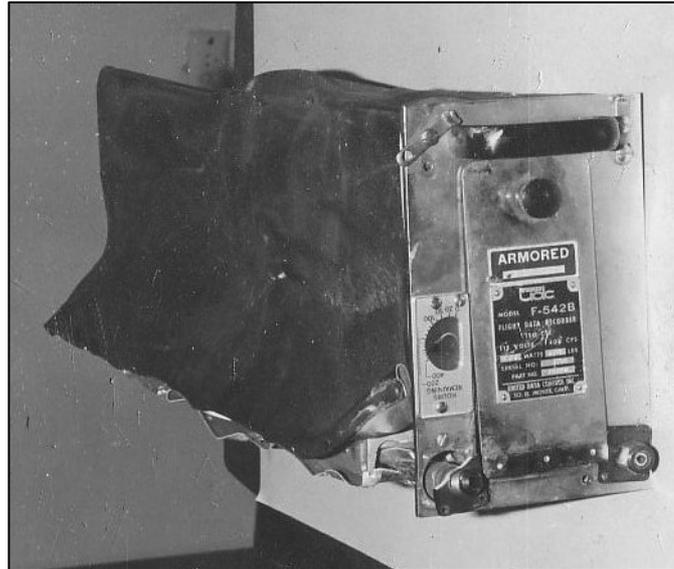
Figure 1: FDR from VH-RMQ

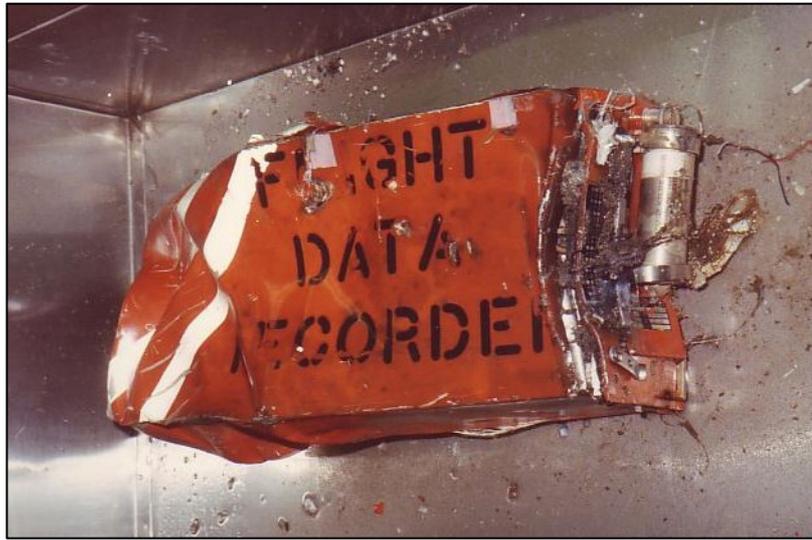
Figure 2: FDR from VH-IWJ

⁶ Pressure altitude, indicated airspeed, magnetic heading, vertical acceleration (load factor) and microphone (radio) keying versus time.

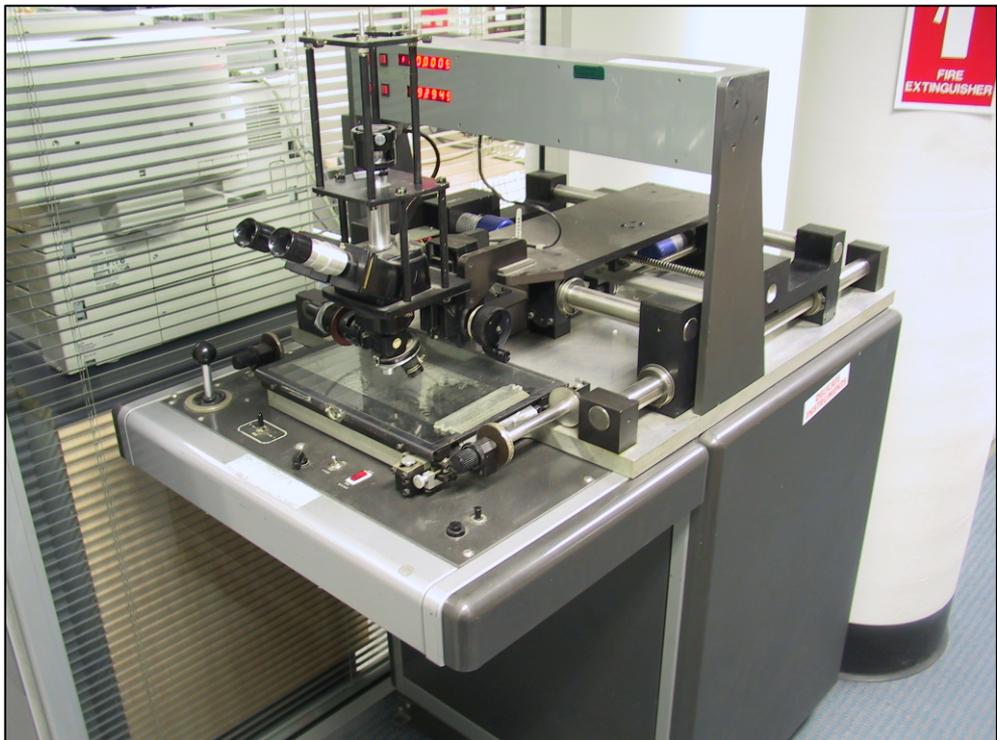
Figure 3: Microscope readout table for analogue (foil) FDR

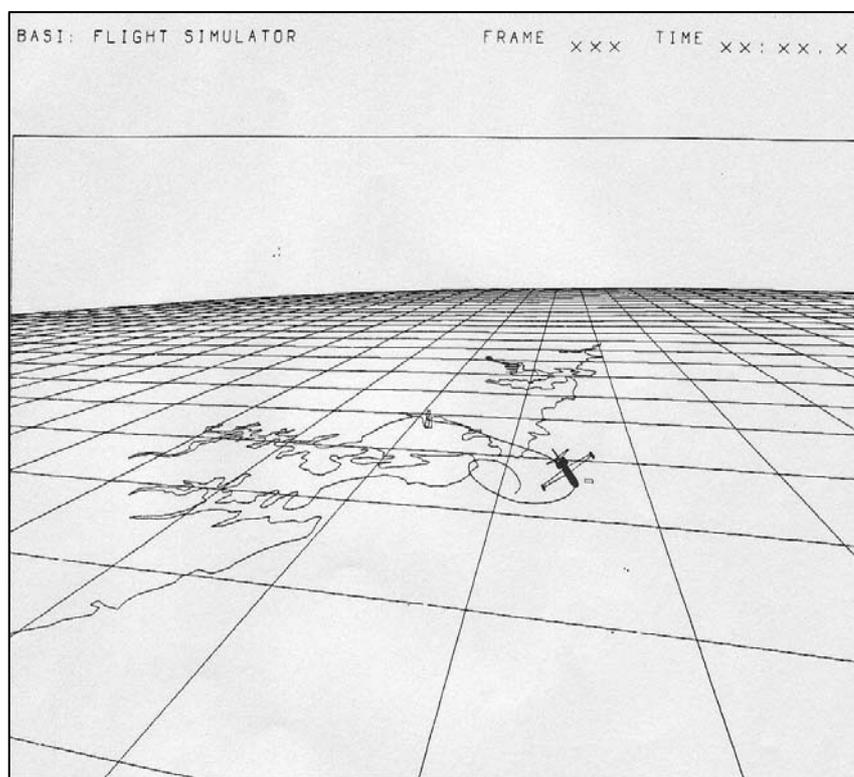
Figure 4: Sample output from the PS300

In 1980 it was proposed⁷ that the Air Safety Investigation Branch⁸ develop a computer graphics system. In 1984, the Bureau of Air Safety Investigation (BASI) introduced its first computer graphics system which made BASI one of the first government accident investigation authorities to use this technology. The system comprised an Evans and Sutherland PS300 monochrome vector graphics workstation hosted by a PDP 11/45 mini-computer. This system could animate a simulated instrument panel, an ILS approach as well as a general 3-dimensional view.

The accident to VH-IWJ was one of the first in Australia to be investigated using this technology.

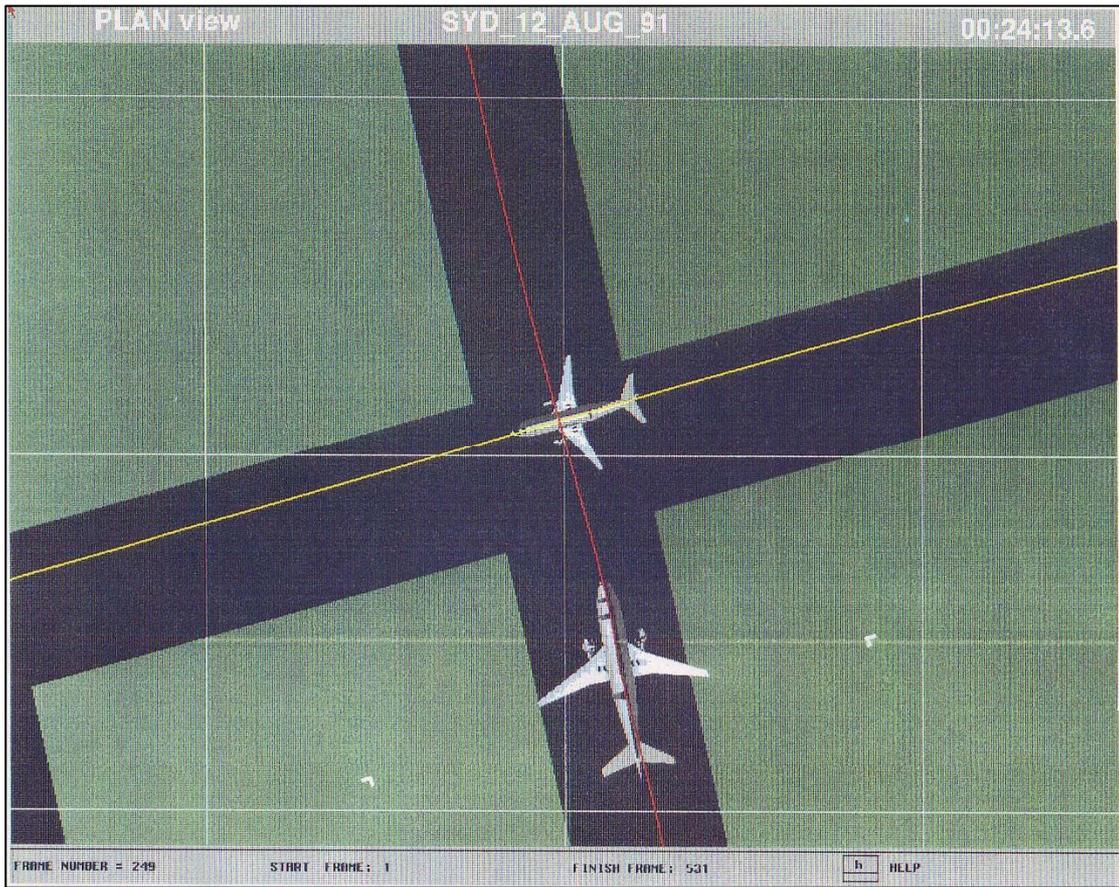
Figure 5: Output from AAIS computer graphics system

FDR data from both aircraft was examined and a computer graphics animation of the incident was produced. The computer graphics system used was initially developed by BASI in-house before development was continued by a contractor. The hardware platform was a Silicon Graphics Iris 4D/70 workstation and the software used was the Aircraft Accident Investigation System (AAIS) software. Output from AAIS is shown in Figure 5.

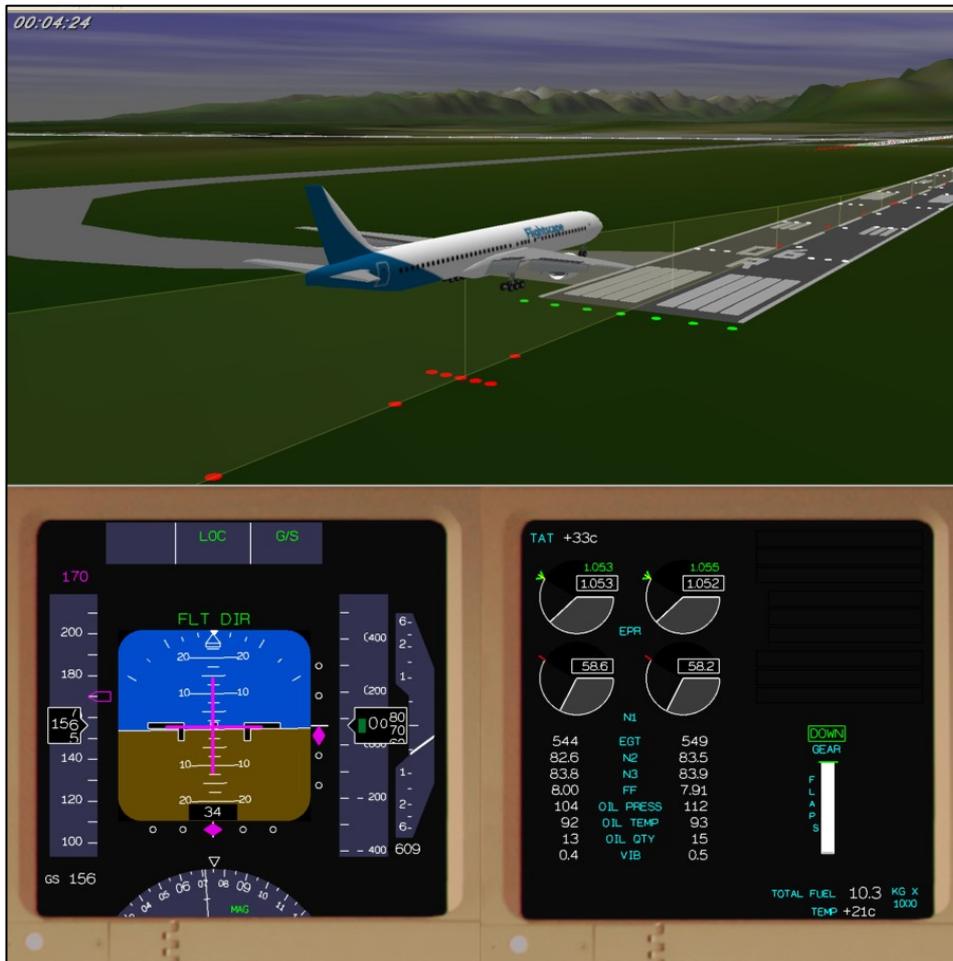
Figure 6: Sample output from Insight Animation

Insight Analysis and Insight Animation were used in the 9M-MRG investigation. A demonstration view, obtained by using Insight Animation, is shown in Figure 6.

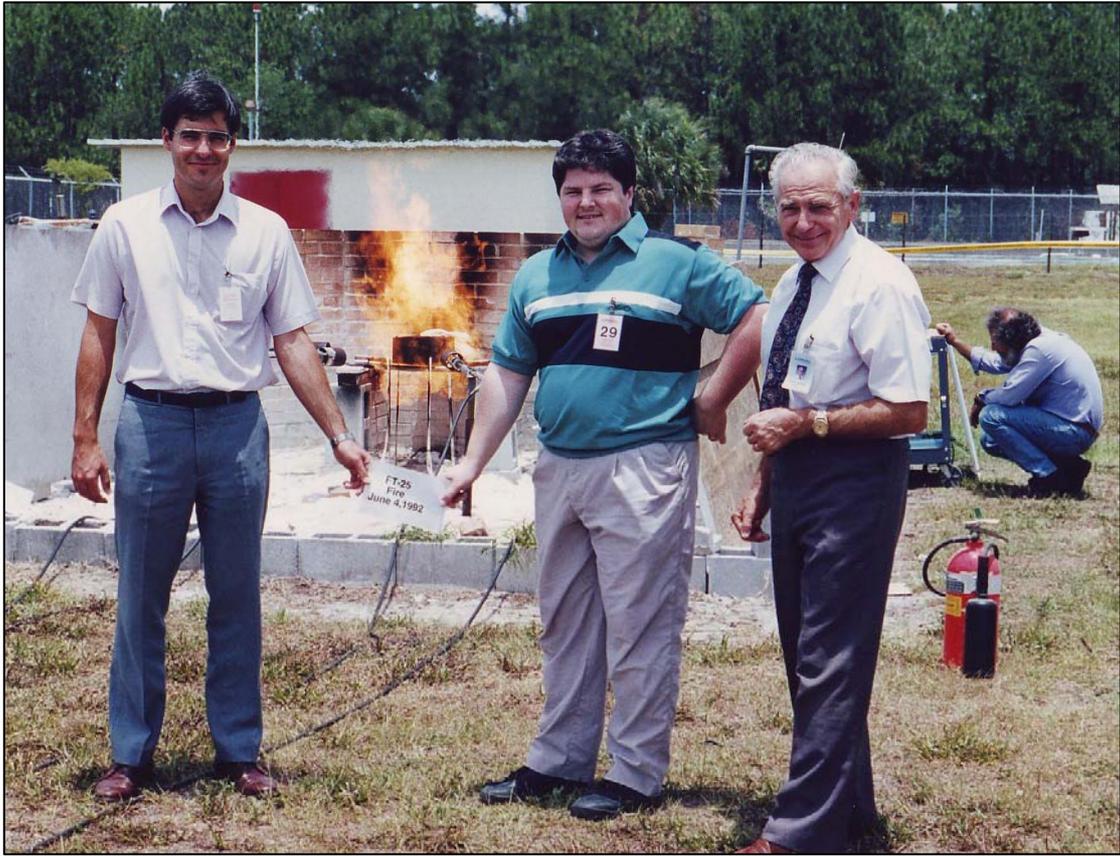
Figure 7: Fire test of a Loral Data Systems recorder, Florida, 1992

TSO¹⁶:	Recorder:	Date:	Impact:	Fire:
C51	FDR	Aug. 1958	100g for 11 milliseconds	1,100°C for 30 minutes 50% of outside area
C84	CVR	Nov. 1963	100g for 11 milliseconds	1,100°C for 30 minutes 50% of outside area
C51a	FDR	Jan. 1966	1,000g for 5 milliseconds	1,100°C for 30 minutes 50% of outside area
C123	CVR	May 1991	1,700g for 6.5 milliseconds	1,100°C for 30 minutes 100% of outside area 50,000 BTU/hour ----- 260°C for 10 hours
C124	FDR	Feb. 1992	3,400g for 6.5 milliseconds	1,100°C for 30 minutes 100% of outside area 50,000 BTU/hour water calorimeter ----- 260°C for 10 hours
C124a	FDR	Jan. 1996	3,400g for 6.5 milliseconds	1,100°C for 60 minutes 100% of outside area 50,000 BTU/hour water calorimeter ----- 260°C for 10 hours
C123a	CVR	Feb. 1996	3,400g for 6.5 milliseconds	1,100°C for 60 minutes 100% of outside area 50,000 BTU/hour water calorimeter ----- 260°C for 10 hours
